# Bi Directional Isolator Relay Delay

## SERVICE BULLETIN

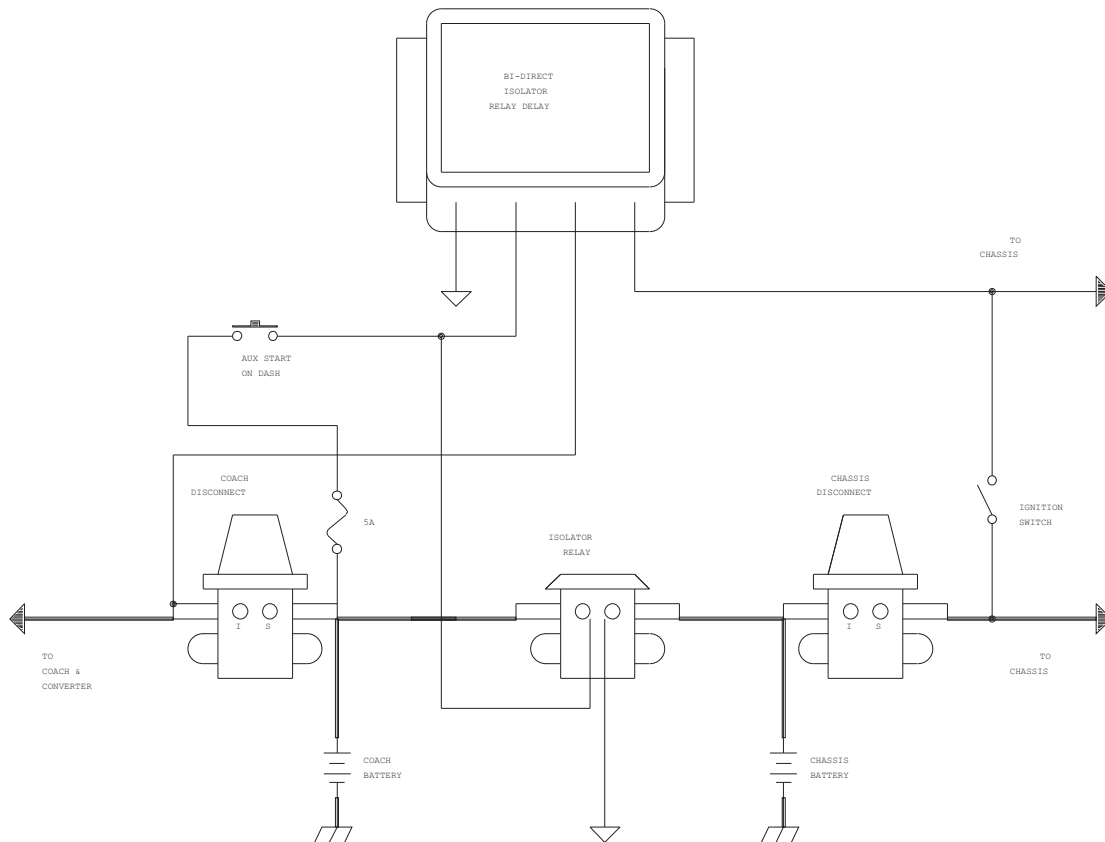
Intellitec's Bi-directional Isolator Relay Delay (BIRD) has worked very well when installed properly. However, there has been some misunderstanding about the proper connection of the coach Battery Disconnect relay and the isolator relay. For the **BIRD** and the Disconnect relay to operate properly, the isolator relay should be connected to the **Battery** side of the relay. If the isolator relay is wired to the system side of the disconnect relay, a few "problems" may appear.

The first problem occurs immediately after driving the vehicle. The light on the Battery Disconnect Panel will remain illuminated for a short period of time, regardless of the state of the disconnect relay. This may give the impression that the Battery Disconnect system is not working properly. In reality, this is due to the isolator relay remaining engaged due to the high battery voltage from being charged.

Another problem that may occur is the lack of charging of the batteries while driving. This will occur when the Battery Disconnect, either the Chassis or Coach, is turned off before the vehicle is started. After the engine is running, the **BIRD** will energize the isolator relay and try to charge the battery but will not be able to due to the open disconnect relay.

These problems, although not serious, can be very frustrating to a customer. All of these problems can be avoided if the isolator relay is wired on the **Battery** side of the disconnect relay. The following diagram illustrates the proper method of wiring the **BIRD** into the coach.
